) Bankruptcy Case No.: 19-30088 (DM)
) Chapter 11
) (Lead Case) (Jointly Administered)
)
) RESPONSE TO THE NOTICE OF THE
) REORGANIZED DEBTORS' FORTY-THIRD
) OMNIBUS OBJECTION TO CLAIMS
) REPORT OF ARBORIST (Correction)
)
) **DATE: December 15, 2020**
) **TIME: 10:00 a.m. (Pacific Time)**
)
) **PLACE: (Telephonic Appearances Only)**
) **United States Bankruptcy Court**
) **Courtroom: 17, 16th Floor**
) **San Francisco, CA 94102**

Subject: Trees at 1721 N. Recreation Avenue, Fresno, CA

Tree Assessment & Appraisal

Residential Property at
1721 N. Recreation Ave., Fresno, CA

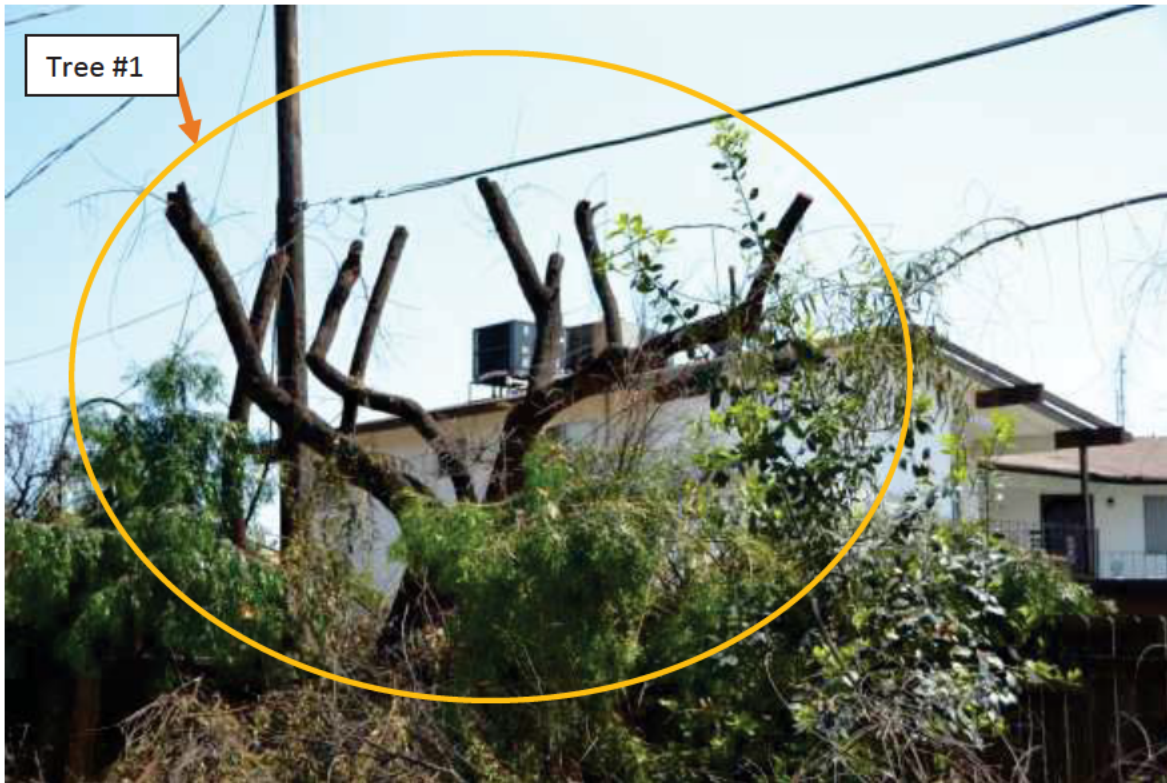
Photo 1

Tree #1, an African Sumac, has two main trunks, with a total **Diameter at Breast Height (DBH)** of 23 inches. The tree had been cut to approximately 12 to 15 feet above the ground. There were only **heading cuts** made to the branches, with no cuts pruned to a lateral large enough to assume the terminal role, known as a **reduction cut**, as advised and recommended in the ANSI A300 Part 1 9.3.1 Utility pruning standards (see Appendix B, ANSI A300 Standards for Utility Tree Care - Tree Care Industry Assoc., Inc., Pg. 8). There were several **stub cuts**, and a few poorly made, or ragged cuts with peeled bark and jagged ends, along with many dead branches left behind (see Appendix A, Photos 4 & 5). I did not see conclusive signs of directional pruning on this tree. The tree was virtually stripped of live foliage. Based on Photo 7 provided by Ms. Wheeler, this tree was healthy and robust without any serious problems before the recent cutting took place.

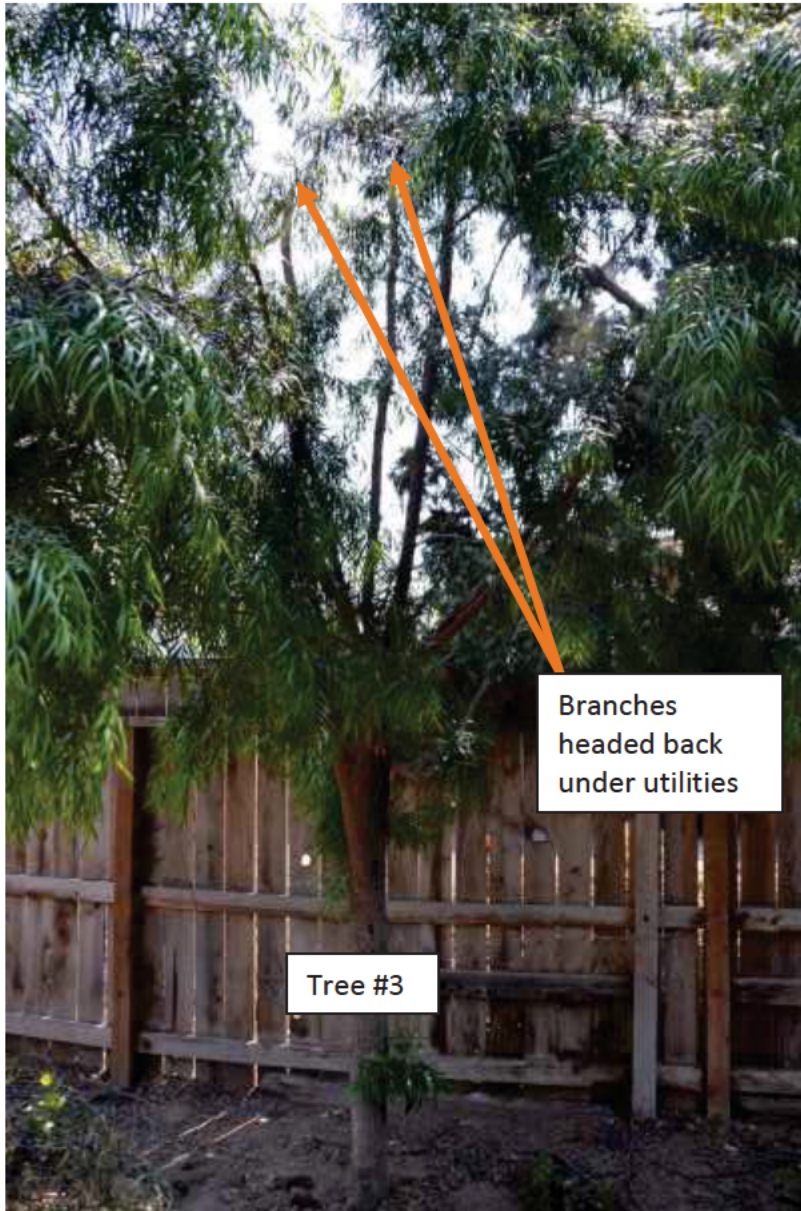
Photo 9

Tree #3, a Fern Pine, has a DBH of 6 inches. The branches of this tree were headed back to approximately 10 feet from the ground. It is a young tree with good vigor. About 60% of the trees foliage prior to cutting remains (see Appendix A, Photo 9).

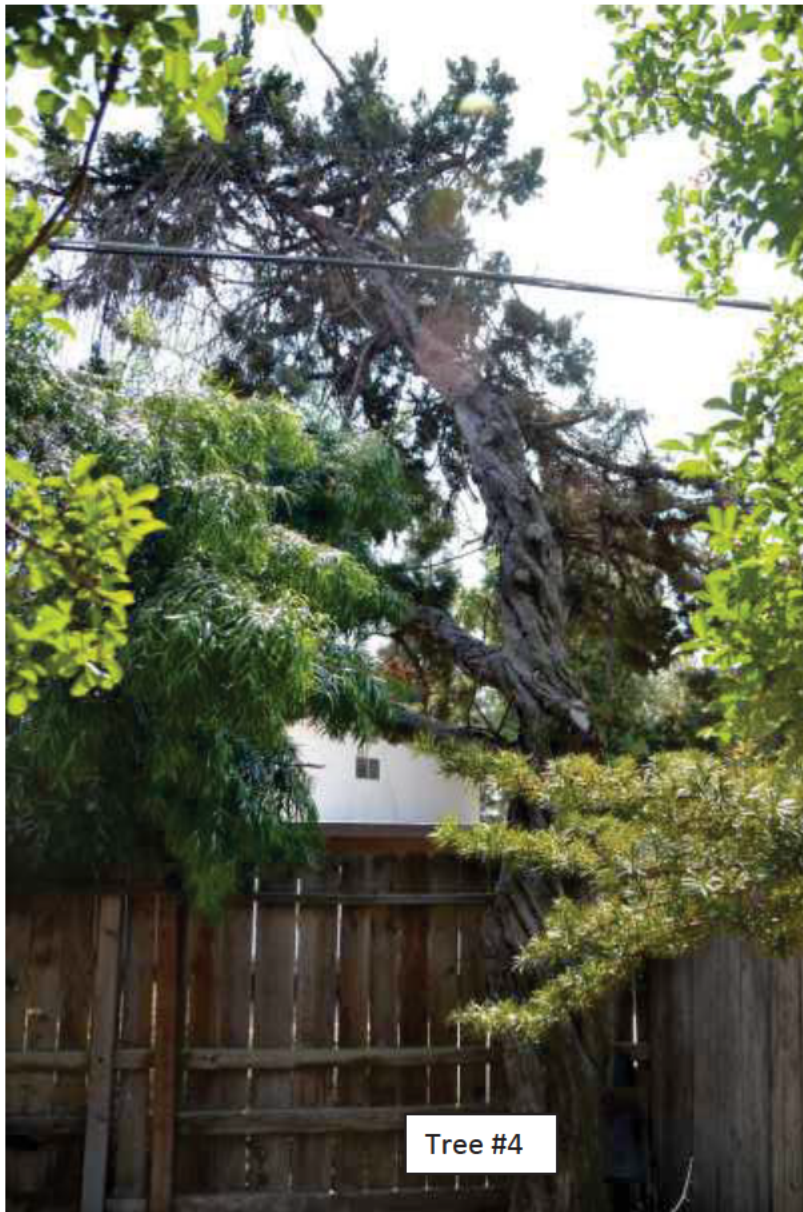
Photo 10

Tree #4, a Hollywood Twisted Juniper, has a DBH of 19.5 inches. It was cut in such a way as to remove its lateral branches, which were growing directly under the utility wires (see Appendix A, Photo 10). Most of the cuts from this work were stub cuts or ragged cuts (see Appendix A, Photo 11). . Past and recent trimming has pushed the growth of this tree toward the property behind Ms. Wheelers' property (see Appendix A, Photo 10).
